## **Summey Engineering Associates, PLLC**

Reference: Building Structure Report  
205 S. Cox Street  
Asheboro, NC 27203  
SEA Job No. E-8628

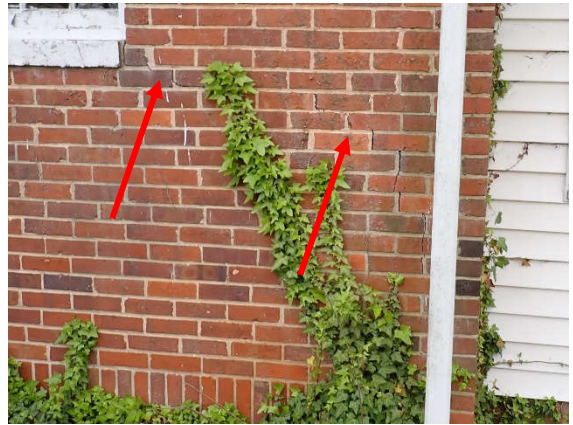
1. Brick veneer throughout the house exterior is failing. Areas of significant vertical and stair step style cracking are present at several locations. Along the left upper gable end of the house, multiple stair step style cracks are visible over each side of the second story window. At the rear of the house, more cracking is visible, typically of 1/4-inch or more in width. Many of the cracking tends to be located in the areas surrounding the door and window openings. Similar cracks are also present along the front of the house above and/or below the windows and front entry door. Other areas of cracking, not specifically mentioned, may also be present. Multiple factors may be contributing to the brick veneer's failure, such as settlement due to an insufficient or damaged footing. Another factor could be the condition of the brick ties which are responsible for anchoring the veneer to the wood framework of the house. If too few brick ties were used during construction, or if the existing brick ties have rusted and corroded over time, then the veneer will not be held in place sufficiently and could easily begin to shift, as appears to be occurring at this property. To properly repair the existing veneer, it will likely be necessary for the exterior veneer to be removed in its entirety. Then, the veneer would need to be replaced, from the ground up, beginning with a new concrete footing being placed in the ground, assuming the existing footing beneath the veneer is insufficient or non-existent. It should be noted, the foundation layer of the brick as visible from the basement area, which is a separate inner layer from the outer veneer, appears to be in generally good condition. No signs of excessive cracking or settlement were visible in the inner foundation layer at the time of our inspection. However, we did observe extensive moisture intrusion through the brickwork from ground water saturation. The lot along the front of the house is generally damp and is sloping towards the front foundation wall. More information about drainage and lot slope will be given in another section of this report. If during the exterior brick veneer repair foundation settlement, currently concealed, is revealed, additional remedial measures such as the installation of a series of helical piers may also be required.

*Picture 2 Veneer cracking at front of house, right*

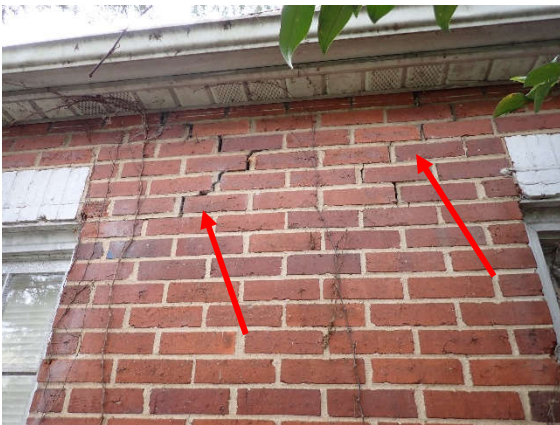
*Picture 3 Veneer cracking at front of house, left*

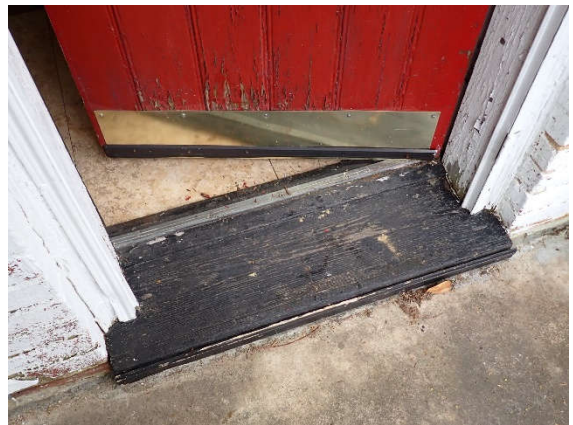
3. Moisture damage was visible at the front door threshold and trim work surrounding the door. Rotten and damaged wood will need to be replaced, along with flashing and other weather proofing measures installed, to ensure the door opening is watertight. The rear basement door is also in poor condition and must be replaced.

*Picture 4 Moisture decay, rot damage at front door threshold & trim*

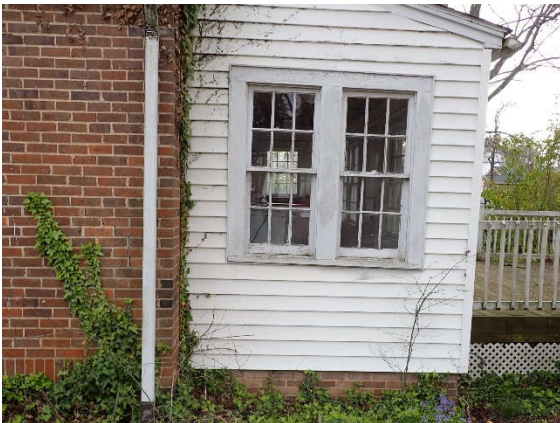
5. A sunporch addition has been built onto the right end of the house sometime in the past. At the time of our inspection, the porch structure appears to be settling and pulling away from the house. Extensive measures to reinforce the sunporch foundation will likely be needed or the porch addition in its entirety may need to be demolished and rebuilt.

*Picture 5 Right end sunporch addition, may be settling & pulling away from house*

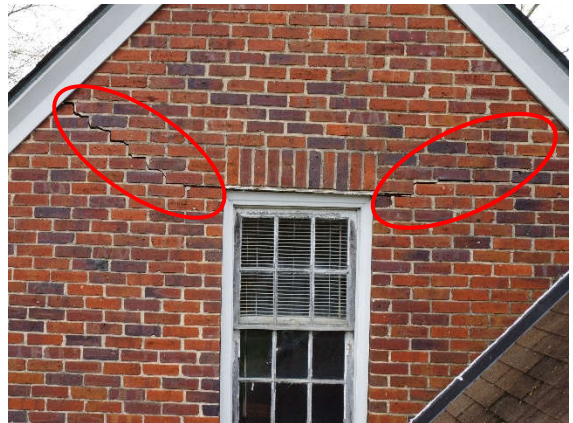
*Picture 6 Veneer cracking, left gable end, over 2nd story window*

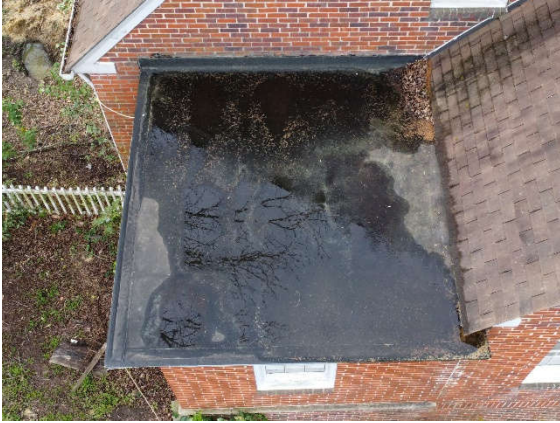
2. The roof was visually inspected from the ground. Based on our observations, it appears that the roof is in poor condition and may be leaking at several areas. Water is ponding on the flat roof at the left end of the house, over the addition. Flashing is missing at multiple locations. There are holes between the brick and fascia or soffit trim at areas as well. As a result, the building envelope is not weather tight and we believe water to be regularly entering into the framework of the house. It is unknown if moisture decay damage has occurred to portions of the inner framing which is not currently visible. But it was obvious that the exposed trim and woodwork that is visible has experienced decay and therefore must be replaced. The entire existing roof shingling would need to be removed

*Picture 7 Standing water on flat roof, left rear addition*

- along with existing associated trim and flashing. When the roof framework and sheathing is exposed and visible, any damaged components would need to be replaced or reinforced as needed. Then a new roof along with all associated flashing, trim work, and exterior cladding can be replaced.

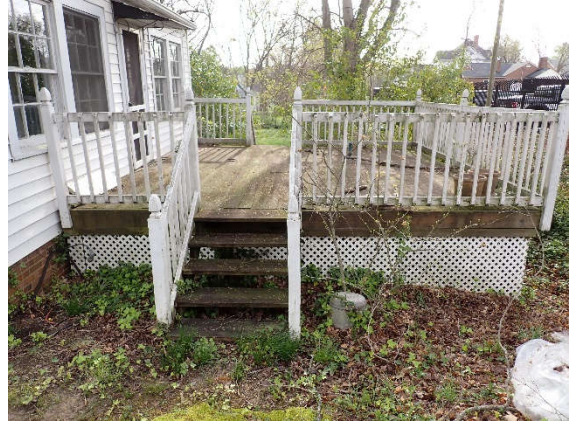
6. The wooden decks at the right end and front of the house are in poor condition. Expansive wood decay is present. All decayed or otherwise damaged wooden components must be replaced.

*Picture 8 Side and front decks, poor condition*

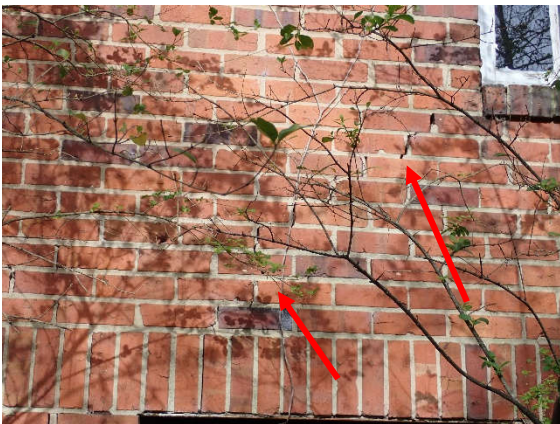
*Picture 9 Veneer cracking, rear of house*

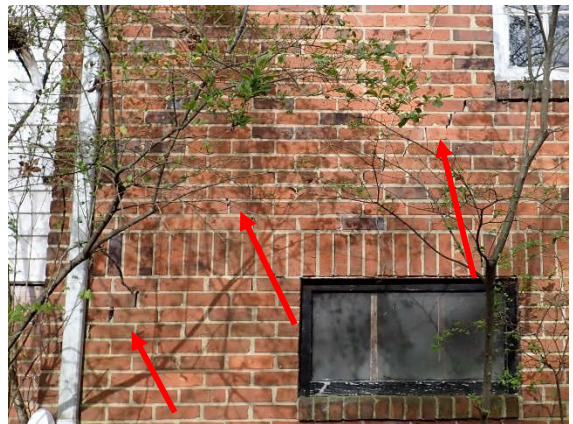
*Picture 10 Veneer cracking, rear of house by corner*

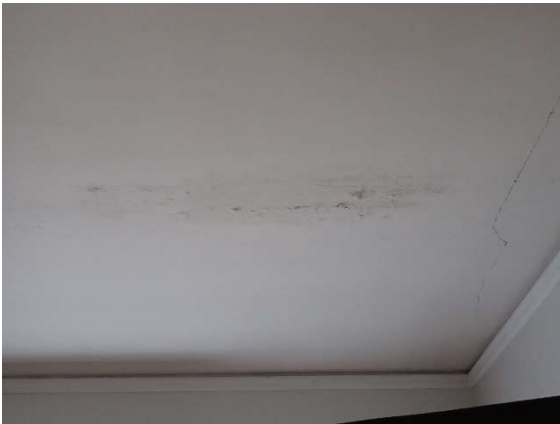
9. Portions of the plaster finishes throughout the house show signs of stress and/or structural cracking, likely as a result of natural settlement and movement to the home over time. Signs of water damage from roof and/or plumbing leaks were also visible at certain areas.

*Picture 11 Water & cracking damage to interior ceiling*

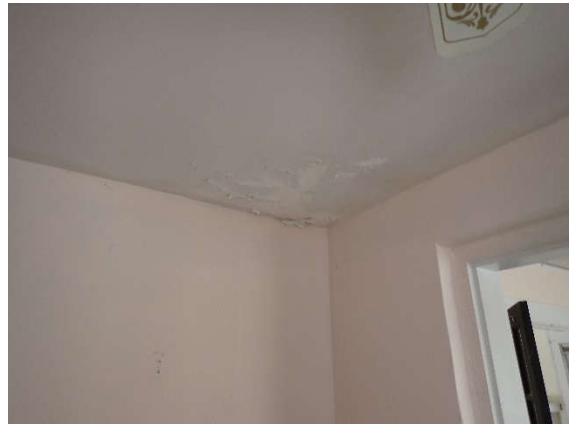
*Picture 12 Water damage to interior ceiling*

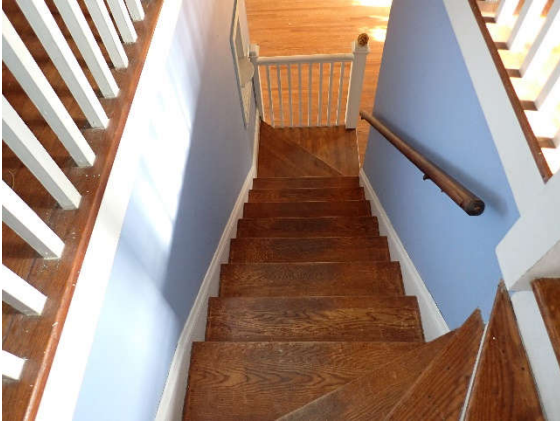
4. New restrooms would have to be built to meet ADA requirements.
5. Stairs to second floor of house are not ADA accessible, nor do they meet current NC Residential Building Code requirements (tread depth and step height dimensions are not compliant). The upstairs of this house would have to be closed off to the public and/or an elevator would need to be installed. The stairs down to basement also do not meet current Code requirements.

Picture 13 Existing interior stairs, not Code compliant

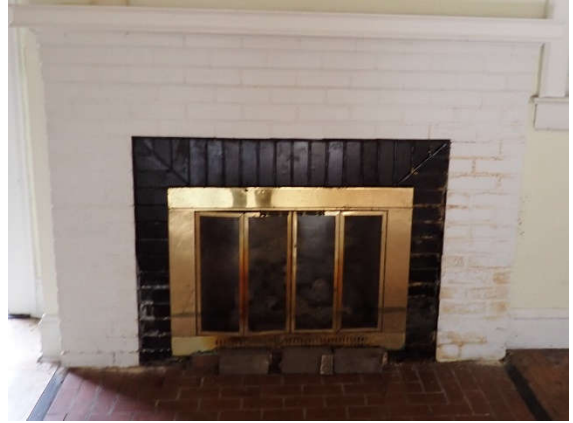
Picture 14 Moisture intrusion through fireplace brick (from exterior)

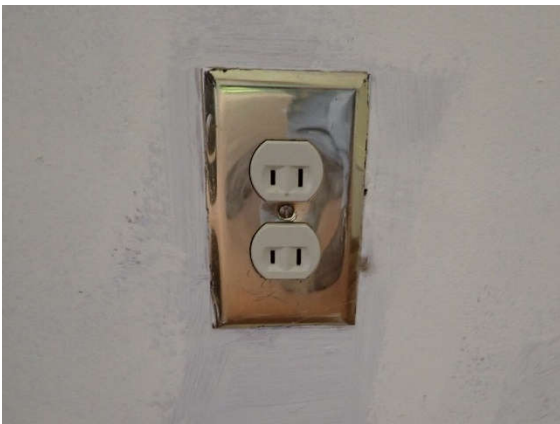
Existing electrical wiring throughout, which is original to the home, appears to be 2-wire non-grounded conductors. Some wiring and outlets may have been upgraded over the years, but all wiring that is not Code compliant will need to be replaced.

Picture 15 Non-grounded two wire receptacle (typical)

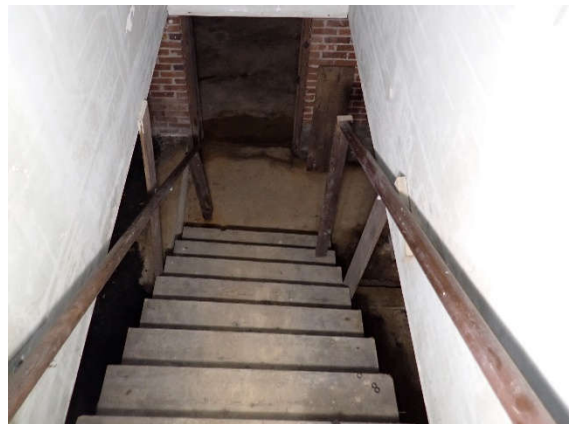
7. The existing wooden stairs leading to the basement from the main level have experience significant moisture decay at the base of the stair stringers and are no longer structurally sound. The existing stairs also do not meet current Building Code standards due to the rise/run height and headroom clearance.

Picture 16 Basement stairs, poor condition & not Code compliant

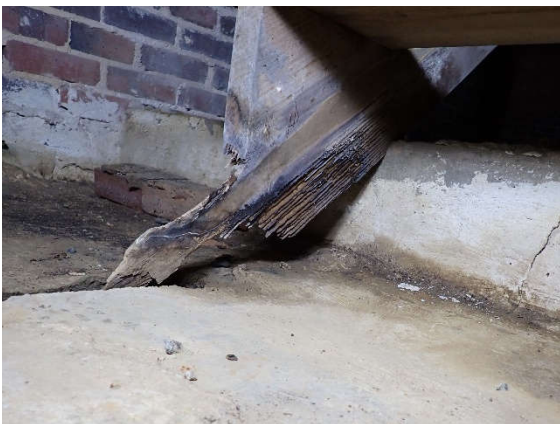
Picture 17 Basement stair stringer, rotted

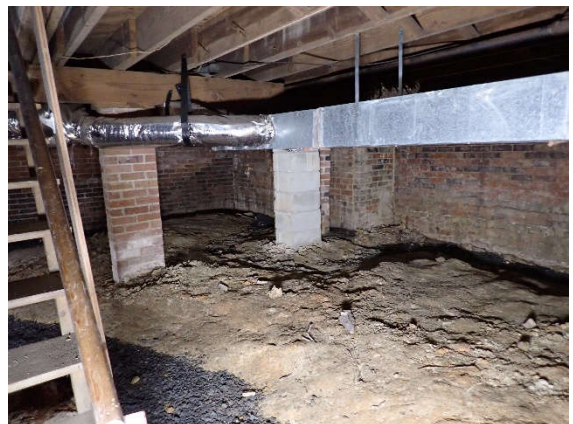
Picture 18 Right half basement/cellar, dirt floor, functional drain system

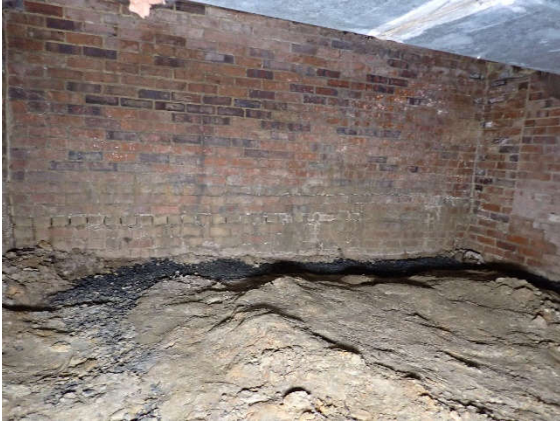
3. Moisture decay damage was present to the floor framing beneath the fireplace hearth. Damaged components must be replaced as needed.
4. Signs of water intrusion were present along the front basement foundation walls. The front yard generally slopes down towards the house from the street and sidewalk. As a result, water has been seeping through the front basement wall for many years. Measures to improve exterior water flow are recommended, such as re-grading the lot as needed, and/or installing exterior inlet drains. A foundation perimeter drain system with sump pump has been installed at the right half of the basement where a dirt floor is present. This drain system appears to be functioning as intended. While this drain system is advantageous, it does not prevent water from protruding through the walls. Therefore, measures to prevent intrusion from the exterior are recommended. It may be advantageous to excavate along the front of the house and install a water proofing membrane on the wall surface along with an exterior perimeter foundation drain system at the footing level. However, if foundation is excavated, great care must be taken not to damage the structural integrity of the existing house.

*Picture 19 Moisture intrusion through front basement wall (typical)*

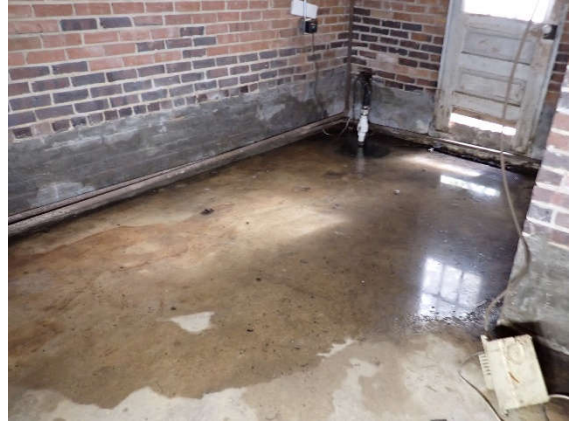
5. The left half of the basement contains a concrete floor. There is a sump pump located at the back left corner of the basement (separate from the sump pump at the right side, referenced above). This sump pump at the left side basement was not functioning at the time of our inspection and multiple inches of standing water was present at this area as a result.

*Picture 20 Standing water at basement, left half*

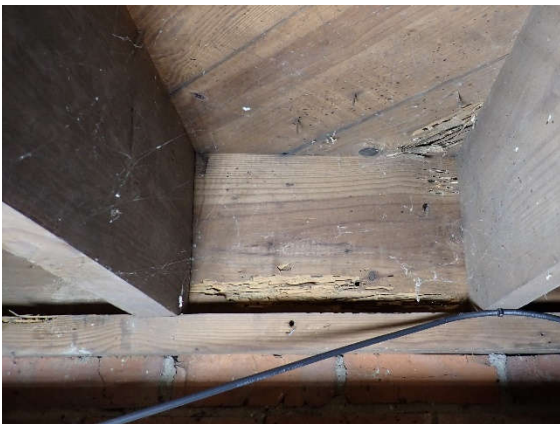
1. Structural damage from moisture decay was visible to the wood framing components of the floor structure as visible from the basement, beneath the first floor hall bathroom. All damaged joists and sub-flooring components would need to be replaced as needed.
2. Damage from a past termite infestation was visible on a portion of the rim joist and sub-flooring along the left side basement wall, adjacent to the addition crawlspace. This damage did not appear expansive but reinforcement to the

*Picture 21 Termite damage, left side basement wall*

damaged area is advised. We also recommend for the house to be inspected by a qualified pest control professional and treatment provided as recommended by them to ensure no active or future infestations occur.

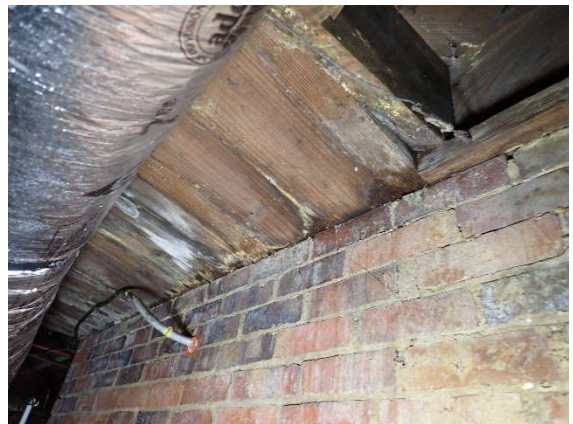
*Picture 22 Moisture decay damage to wood structure beneath fireplace hearth*

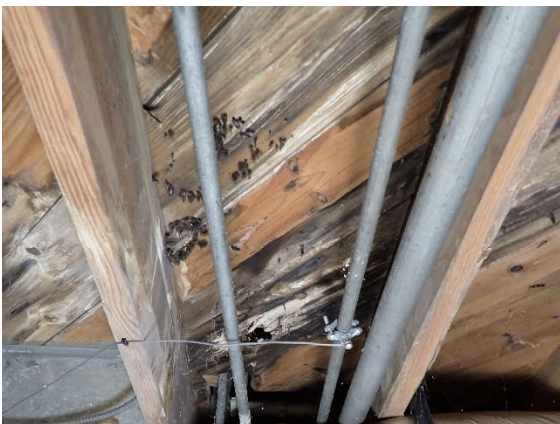
*Picture 23 Moisture decay damage to floor structure beneath 1st floor hall bathroom*

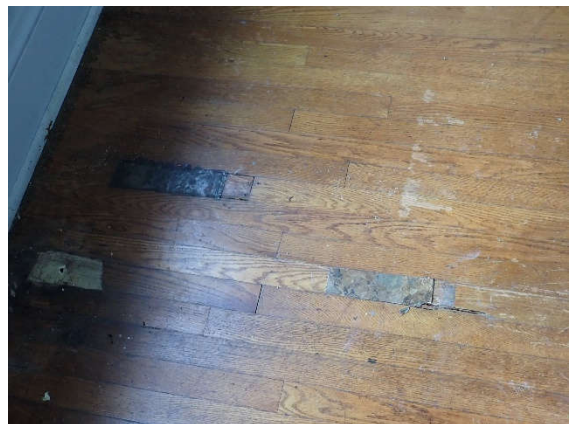
6. Termite damage was visible to areas of the interior wood flooring. We assume that when carpet was previously in place, termites infested the area between the carpet and floor. The damage appeared isolated to a few specific locations, primarily in the dining room.

*Picture 24 Termite damage to hardwood floor, dining room*
